Designated Substances Management Plan

**Prince Andrew PS
1950 Kelly Rd., LaSalle, Ontario, N9A 6Z6**

Current Version: February 13, 2022

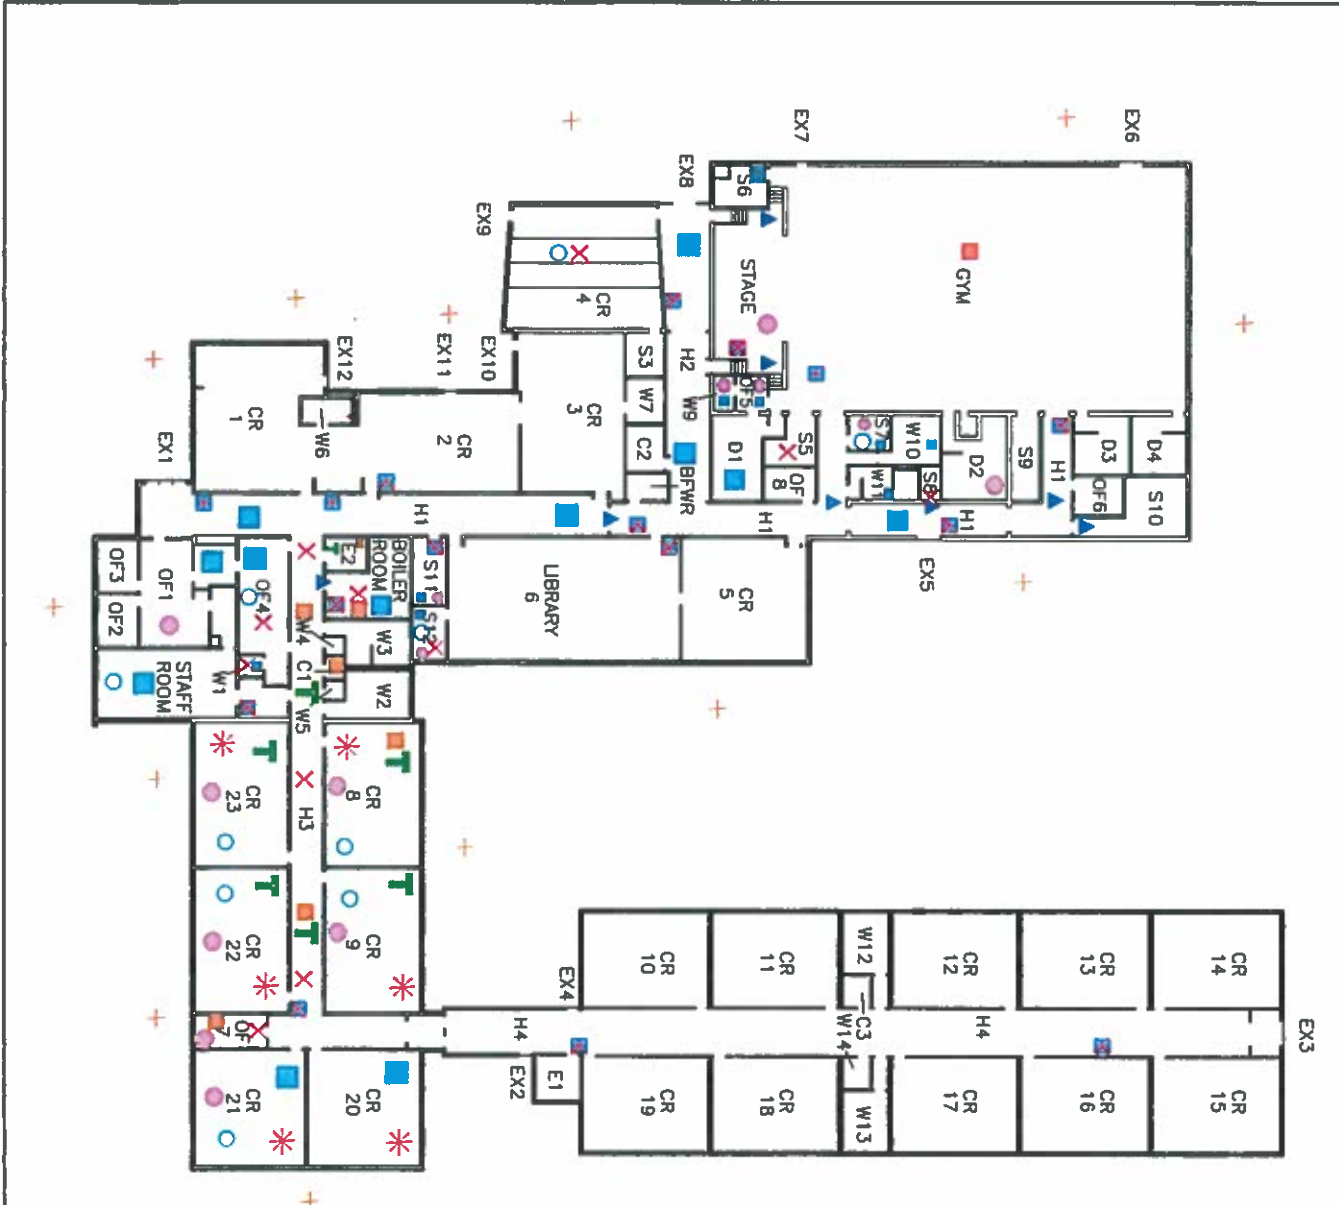
- ASBESTOS LEGEND**
- X = THERMAL INSULATION
 - = CEILING TILES
 - ▲ = FIRE DOOR LINING
 - + = CAULKING (INTERIOR & EXTERIOR)
 - = CHALKBOARD
 - = FLOOR TILES/VINYL SHEET
 - = SINK MASTIC
 - T = TEXTURE COAT
 - = PLASTER
 - = ADHESIVE PUCKS
- NOTE:**
ASBESTOS MAY BE IN OR AROUND THE SYMBOL.
